INFORMATION REPORT

SUBJECT Bottlenecks Production at the Oberspreewerk

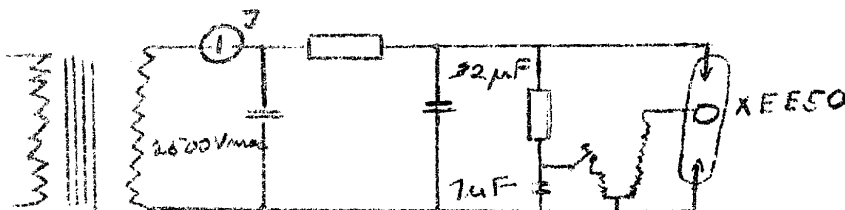
1. Because of the lack of "Hydrokollag", the production of the Al 4 and Cl 1 tubes was stopped. As a result, orders for one million of these tubes could not be filled; the "Hydrokollag" produced at Siemens Plania in the Russian Zone proved unusable, since the tube rejection rate rose to 50%.
25X1
25X1
2. There is furthermore a shortage of aluminum oxide used for the lining of the annealing furnaces. Fireclay used as a substitute was unsatisfactory and crumbled easily. Bottlenecks also resulted from the lack of suitable grinding disks and diamond dust. The promise for delivery of diamonds from the USSR was not kept.
3. The impulse lamp XEE 50, produced at the OSW, is used for photography at 1/5000/sec. Its diagram is as follows:

The larger impulse lamp for 30,000 joule works on the same principle. It has the following data:

Intake 6 kw
Output per impulse 9,000 kw
Voltage 5.5 kV
Condenser 137 μ
Filler Krypton

After 2,000 flashes the lamp is useless because it becomes blind by the pulverized tungsten.
